**Performance Evaluation of Schauenburg Industries Ltd.
Fiberglass Ventilation Ducting –
Leakage Assessment**

**Work performed for:
Schauenburg Industries Ltd.
North Bay, ON**

**Project: P-002288.001
MMS.SMM mlevesque 6059973**

Version: March 2016

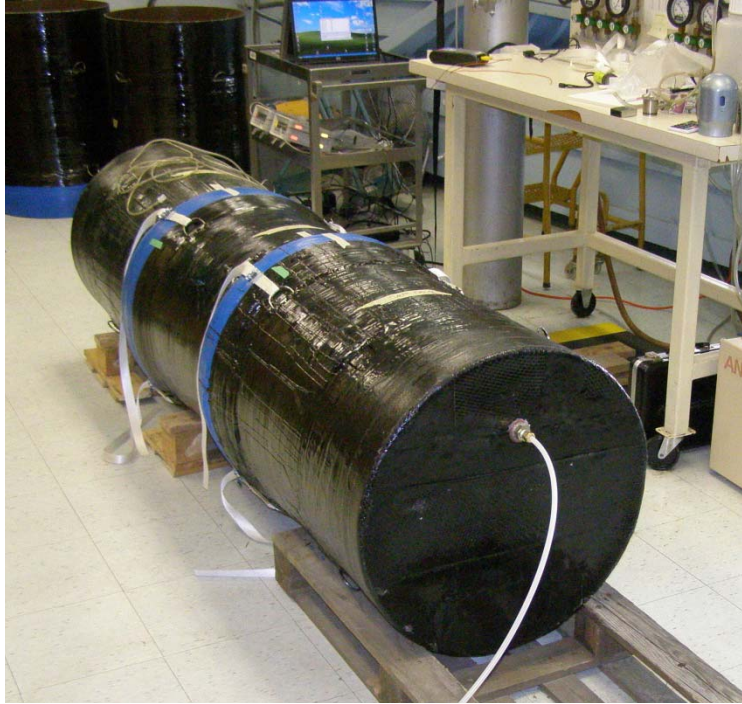
Figure 1 System with 2 joints

The length of the unit where the duct segments were tested individually, with 2 joints was 2.3 m (90 inches) whereas the complete assembly with 5 joints was 4.5 m (178 inches). The system with one individual duct segment and 2 sealed ends is shown in Figure 1 whereas the assembly with all 4 duct segments is in Figure 2.

The system consisted of 0.6 m (24 inch) diameter duct segments connected to two sealed end pieces using cam buckle straps (same as those typically supplied for installation underground). Holes were drilled into the end pieces to install fittings whereby the air supply and instruments could be connected. Rubber gaskets and silicone were used to ensure that there was no leakage at the fittings.

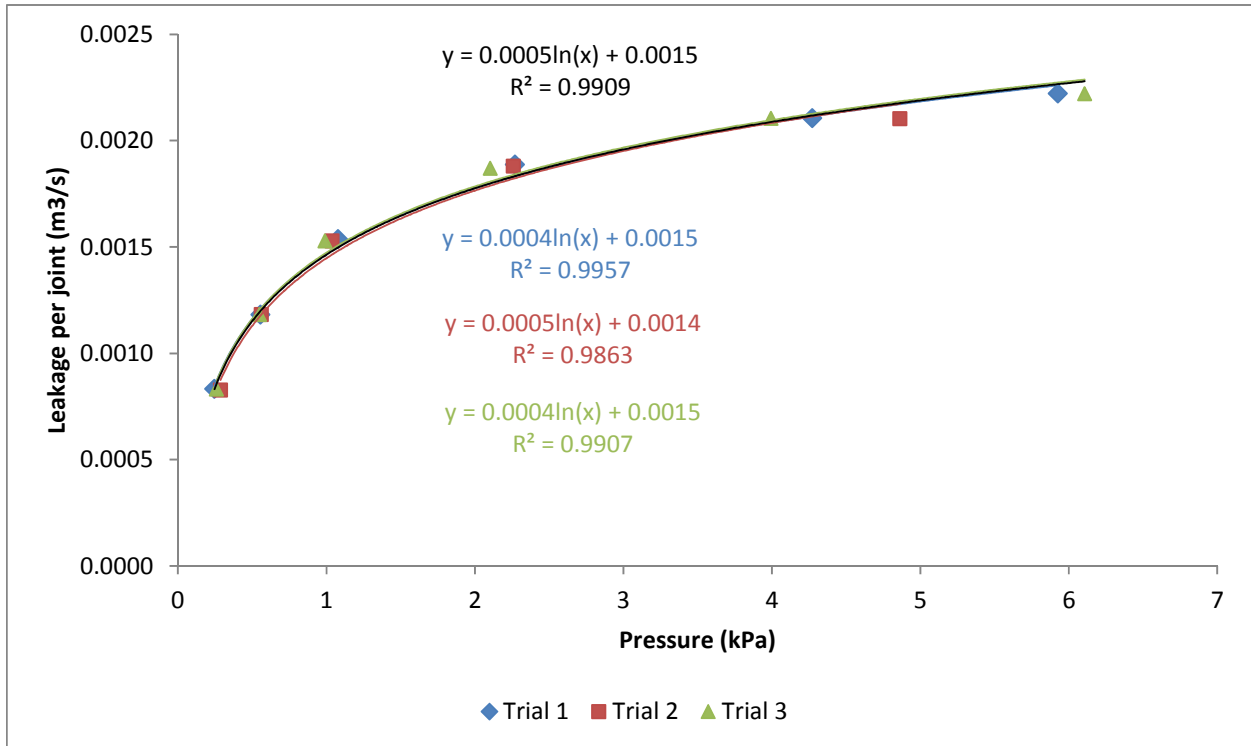
Figure 3 Leakage determined from flowrate measurement test from 3 trials conducted on same duct

It can be seen from Figure 3 that the results obtained from these tests are comparable which indicates that the variability due to installation was low. All the measurements from the three trials were within 10% of the leakage values predicted from the

regression line based on the results from all three trials. Thus only one trial per test was conducted for the other assemblies.

An assessment of the variability of leakage due to installation was conducted by assembling the end pieces (#1 and #2) with duct segment #3. A leakage measurement test was conducted then the system was disassembled. The same duct segments were then reassembled and the leakage test was repeated. This was reiterated a total of three times. The results illustrating the leakage per joint at various pressures for the three trials with segment #3 are presented in Figure 3. A leakage decay test was also attempted but the rate of pressure loss in the system was too quick to measure, thus results are not available for this test.

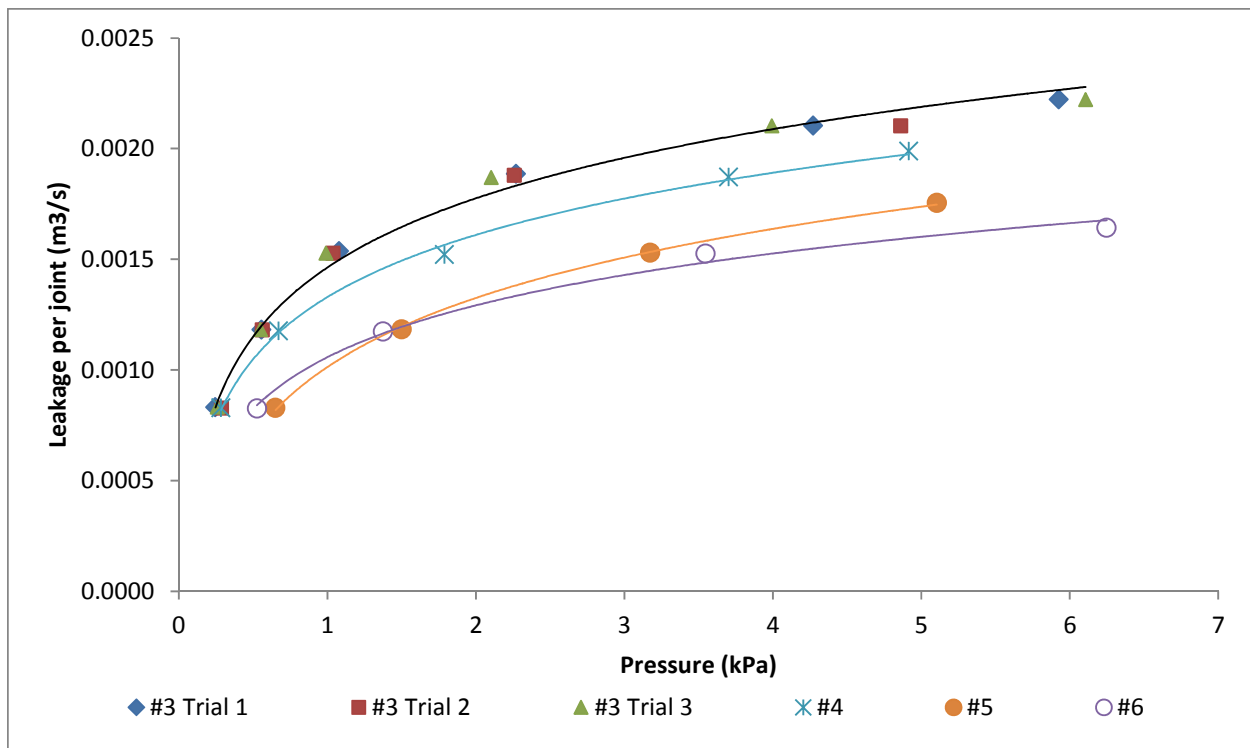
Figure 4 Leakage determined from flowrate measurement method from tests conducted on individual duct segments

It can be seen from Figure 4 that the leakage per joint varied for each segment, up to an average of 27% between the ducts with lowest and highest leakage (#6 and #3 respectively).

Each additional open duct segment (#4 to #6) was then tested individually with end pieces #1 and #2. However, only one trial for each segment was conducted since the previous test indicated that the results from individual tests were repeatable as shown in Figure 3. The results of the tests conducted with the individual segments are presented in Figure 4. A leakage decay test was also attempted but the rate of pressure loss in the system was too quick to measure, thus results are not available for this test.

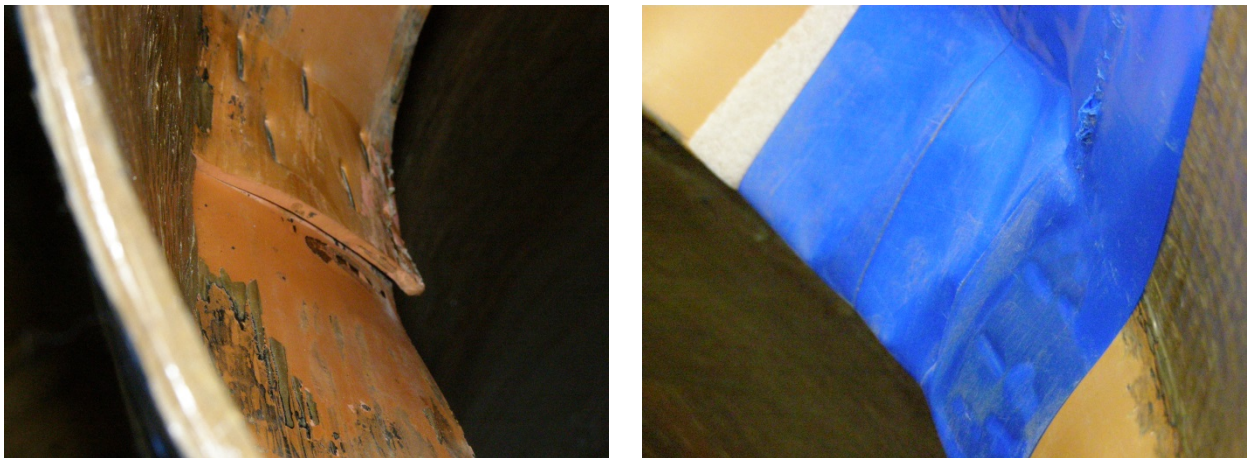
Figure 6 Photo of seal (**Left:** original gasket; **Right:** patched gasket)

It was observed during the previous tests that leakage at the joints was concentrated where the rubber piece used as the gasket inside the duct overlapped onto itself which created a channel whereby air was flowing out of the duct. Thus a patch was fabricated for each duct with foam and secured with adhesive tape to smooth the step produced by the overlapping rubber. Figure 6 shows the original gasket on the left and the patched gasket on the right.

Leakage testing was repeated on the individual segments as well as all ducts as a complete assembly with all the gaskets patched as shown in Figure 6 (right). The results are presented in Figure 7 along with those from duct #3 and all segments with the original gasket for comparison. Table 1 shows the results from the pressure decay test.

The average leakage per joint from the original gasket determined from the leakage measurement method corresponded to 0.0015 m³/s (3.2 cfm) for pressures ranging from 0.5 to 5 kPa (2 to 20" w.g.). It was observed that most of the leakage occurred at the location where the rubber piece used for the gasket overlapped onto itself.

A patch installed on the gasket where most of the leakage occurred resulted in reducing the leakage by roughly 90%, to an average of 0.0002 m³/s (0.4 cfm) per joint, representing an opportunity for improvement. A redesigned gasket was then assessed, where the leakage compared to the original design was reduced by over 50%, to 0.0007 m³/s (1.5 cfm). However, only one segment and one end piece of this type were supplied and there appeared to be manufacturing issues which prevented a good seal with these segments. Nonetheless the redesigned gasket showed improvement with respect to leakage.

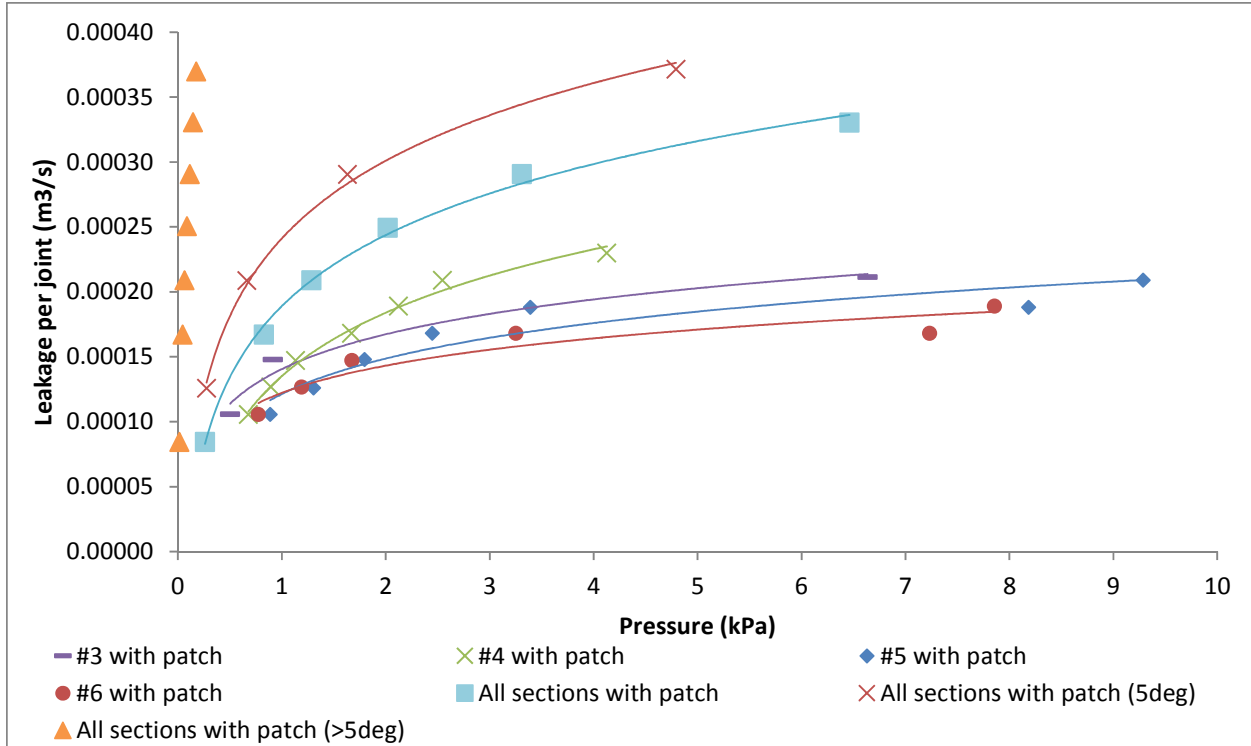
Figure 9 Test results from flowrate measurement method with the joints installed at 5 and 8 degree angles

It can be seen from the results presented in Figure 9 and Table 2 that although the leakage per joint for the test conducted with joints at an angle of 5 degrees were slightly higher for the pressure decay method than from the leakage measurement test, the

values from both tests were similar. It can also be seen that leakage from the test conducted with the joints installed at angles of 8 degrees was higher thus measurements could not be obtained using the pressure decay method.

The results presented in Figure 9 also show that leakage at the joints increased when they were not aligned straight. On average, the leakage per joint increased by 25% for the assembly with the joints at 5 degrees compared to the straight installation, whereas at 8 degrees the leakage increased by 604%.

Testing was also conducted to assess the leakage from systems installed whereby the adjoining segments were installed at 5 degree and 8 degree angles. The results from these tests indicated that although leakage increased in the 5 degree installation compared to the test with the segments aligned straight, the impact was minimal. But, when the system was installed at 8 degrees the leakage at the joints was increased by about 600%.
